PentaFlow + Pyrosol ES: Injector Recovery

Case History 4.3
ESP Cleaning : Maxus/YPF/Repsol Indonesia: Teresia AC6
PentaFlow + Pyrosol ES

Case History 4.4
ESP Cleaning : Maxus/YPF/Repsol Indonesia: Zelda AC-1
PentaFlow + Pyrosol ES

ESP Cleaning – Private Contractor For Pertamina Retrieved Pump – De-scaling Operation On Surface

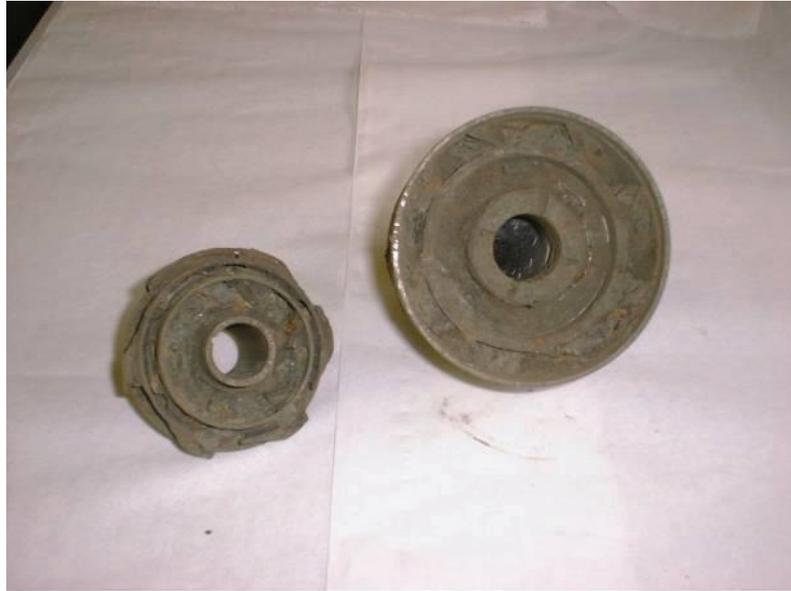
The Teresia AC-6 ESP had been in service for 211 days producing between **150 to 175 bopd** when it went into over load and tripped out. Attempts to re-start the ESP were unsuccessful and no mechanical or electrical faults were noted. This well was noted for its high scaling potential and the tightness of the formation. It was suspected from previous pumps removed from this well that scale had built up between the diffuser and the impeller.

BEFORE : Typical ESP impeller and diffuser – pulled due to scaling.

A treatment of 150 litres of **PentaFlow** was programmed for spotting across the pump in a single 90-minute soak as a pre-cleaning solution. The second stage entailed placing 155 gallons of **Pyrosol ES**, a high performance sulphide and carbonate scale dissolver, across the pump and allowing it to soak for 8 hours. After 8 hours, the **Pyrosol ES** was displaced to 155 gallons of fresh **Pyrosol ES** and the well shut in for 12 hours. **PentaFlow** and **Pyrosol ES** are non-corrosive.

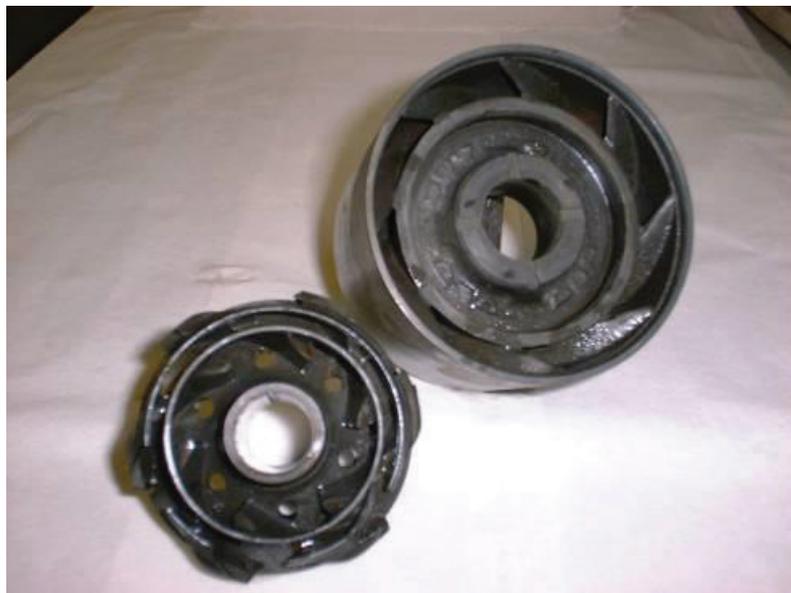
After a total treatment period 21.5 hours, the pump was engaged and operating at full potential without tripping. After seven hours of start up, the well began producing 175 BOPD with no over load on the ESP, cleaning up to **396 bopd** after 36 hours of

AFTER : The same components as above after cleaning with PentaFlow and Pyrosol ES .

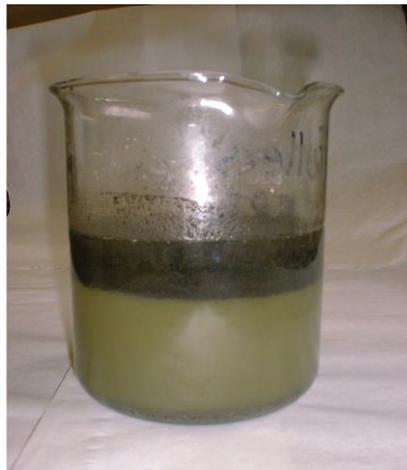
Photo of fluid removed from soak – note the oil separation from the dissolved scale and corrosion products below:

Summary : *Summary: The rate of ESP failure in the fields off Indonesia are extremely high due to scale build up and formation solids plating out on the impellers. Although cleaning these downhole had been field proven with some Operators – others were still pulling ESP's and having them treated at surface. **PentaFlow** was used to soak the ESP's in a bath at ambient temperature to see if this could be done cost effectively. The pumps were soaked in an open tank of **PentaFlow** and allowed to soak overnight. The pumps were removed and proved to be in pristine condition .*
