CASE HISTORIES

Case Histories Contents & Cross References

Well Intervention Chemical Case Histories

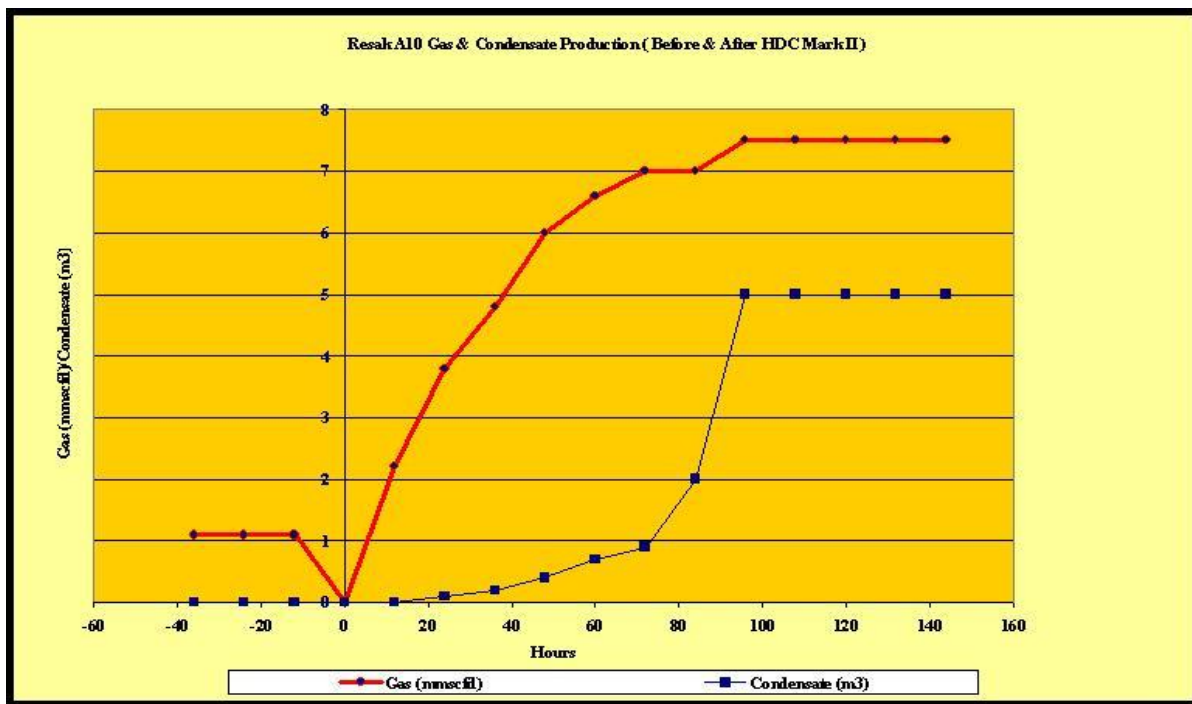
Chart 1: Production Gas Rates Before & After SD27X Treatment

Sample	1	2	3	4	5
Volume bbls	40	40	160	40	40
Cum. Volume bbls	40	80	240	280	320
g/l dissolved minerals	24.24	22.34	32.50	10.83	4.82
Total Litres	6392	6392	25568	6392	6392
Total Grams	154,949.62	142,794.72	830,960.00	69,247.35	30,781.32
Total Kilograms	154.95	142.79	830.96	69.25	30.78
% SD27X In Sample	28.00%	24.65%	31.50%	10.65%	5.00%
Litres SD27X	1,789.76	1,575.63	8,053.92	680.75	319.60
Dissolved g/l	86.58	90.63	103.17	101.72	96.31

Summary: Resak A10 was designed to produce 25 mmscfd, but only produced 10 mmscfd and falling. After pumping 13.0 ppg OBM to kill the well, 250 bbls of acid was pumped. Production dropped to below 1 mmscfd. Besides damage from acid, it was also believed that some of the barite from the OBM had settled and covered some of the perforations. In an attempt to recover some production, a year later almost 70 bbls of SD27X was bullheaded into the well over 26 hours resulting in production of 7 mmscfd.

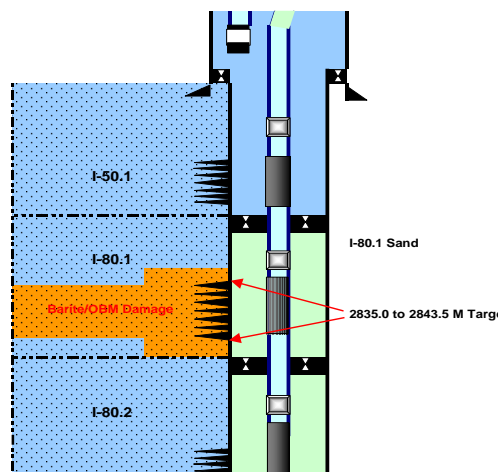
Resak A3 is a dual string gas producer drilled by Carigali offshore Terengganu in 1998. The well was completed as a dual string completion to isolate a higher pressure reservoir at the bottom from intermediate production zones above.

The well was badly damaged by the OBM mud used with the middle (I-80 sand) totally impaired and non-responsive to acid treatments.

The zone was isolated from the lower production and bull-headed with 3500 liters each of PentaFlow/PowerPickle® (50/50) and SD27X and allowed to soak overnight. The well was gas lifted from the SSD successfully producing 11 mmscfd and building.

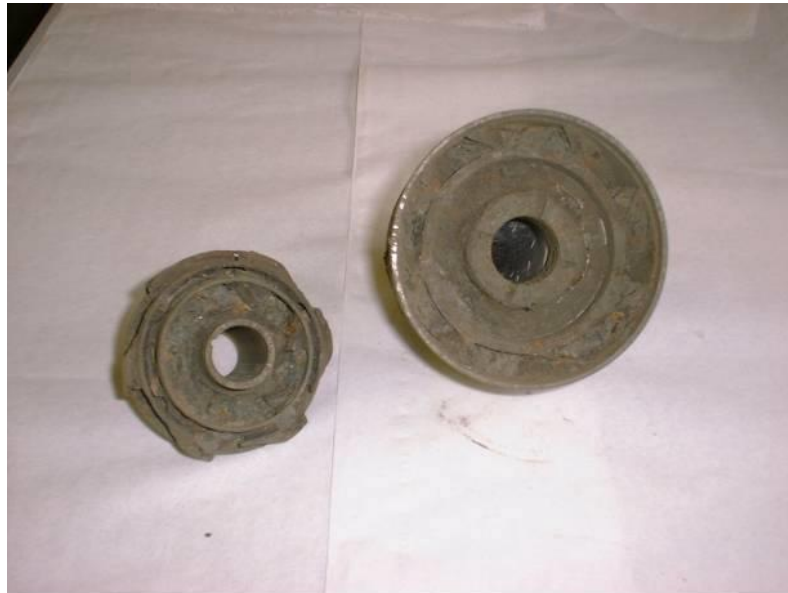
BEFORE : Typical ESP impeller and diffuser – pulled due to scaling.

The Teresia AC-6 ESP had been in service for 211 days producing between **150 to 175 bopd** when it went into over load and tripped out. Attempts to re-start the ESP were unsuccessful and no mechanical or electrical faults were noted. This well was noted for its high scaling potential and the tightness of the formation. It was suspected from previous pumps removed from this well that scale had built up between the diffuser and the impeller.

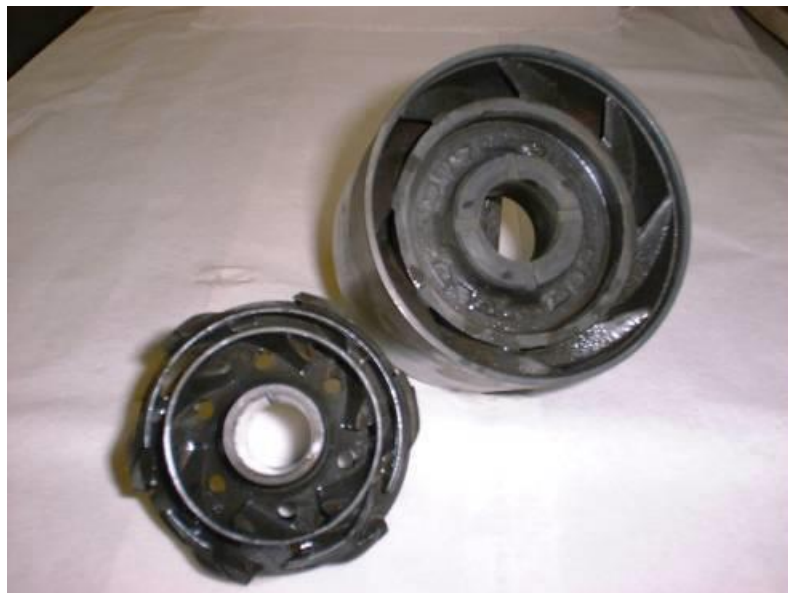
AFTER : The same components as above after cleaning with PentaFlow and Pyrosol ES .

A treatment of 150 litres of **PentaFlow** was programmed for spotting across the pump in a single 90-minute soak as a pre-cleaning solution. The second stage entailed placing 155 gallons of **Pyrosol ES**, a high performance sulphide and carbonate scale dissolver, across the pump and allowing it to soak for 8 hours. After 8 hours, the **Pyrosol ES** was displaced to 155 gallons of fresh **Pyrosol ES** and the well shut in for 12 hours. **PentaFlow** and **Pyrosol ES** are non-corrosive.

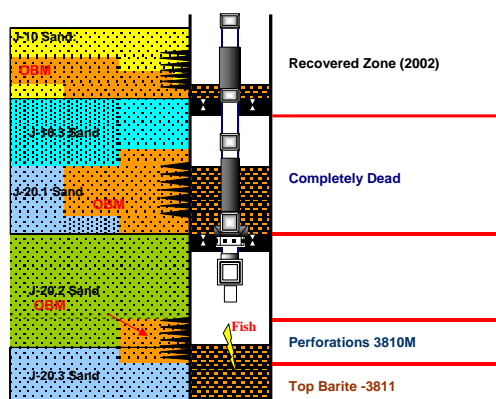
Resak A10 is a dual string gas producer drilled by Carigali offshore Terengganu in 1999. The well was completed as a dual string completion to isolate a higher pressure reservoir at the bottom from intermediate production zones above. Due to communication between

the completions and lack of heavy brine, the well was killed and suspended in 13.0 ppg OBM. On re-entry, it was found that most of the perforations in the short string and long string zones were partially buried under settled barite and OBM. In the upper zone, **SD27X** had been used to restore the well to productivity in 2002, so the same methodology was programmed for the deeper long string which was partially buried under OBM solids. The zone was originally designed to produce 50 mmscfd. At the time of acidizing, the zone was producing between 20 and 22 mmscfd and falling. As CTU was not available – it was decided to bull head the Power Pickle and SD27X although there was no gas lift available. The decision was made expecting the well to take time to clean itself up.

Using 4,000 liters (50/50) **PentaFlow** and **PowerPickle** as a preflush, the lower zone was stage displaced to 9,000 liters of **SD27X**. The well was allowed stand static as the pressure built up over time until it cleaned up and was placed on stream producing 45 mmscfd.

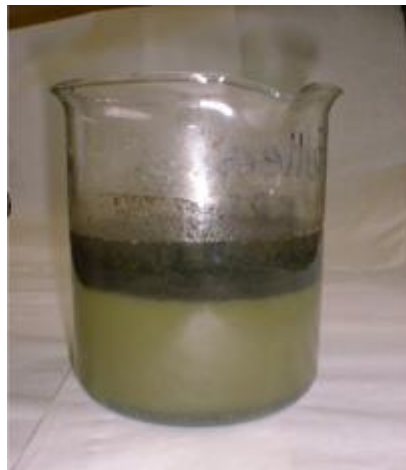
Photo of fluid removed from soak – note the oil separation from the dissolved scale and corrosion products below:

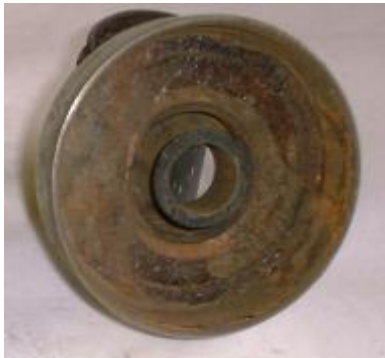
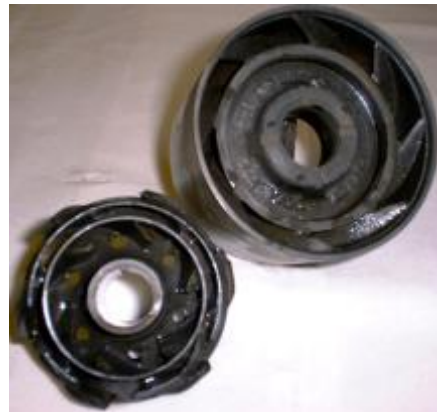
Typical Before & After Condition of ESPs Being Treated With **PentaFlow**

Summary : *Summary: The rate of ESP failure in the fields off Indonesia are extremely high due to scale build up and formation solids plating out on the impellers. Although cleaning these downhole had been field proven with some Operators – others were still pulling ESP's and having them treated at surface. **PentaFlow** was used to soak the ESP's in a bath at ambient temperature to see if this could be done cost effectively. The pumps were soaked in an open tank of **PentaFlow** and allowed to soak overnight. The pumps were removed and proved to be in pristine condition .*
